92-431342/52 H01 BORE = 89.06.26
BOREHOLE CONSOLIDATION MUDS *SU 1710694-A1
89.06.26 89SU-4710051 (92.02.07) E21B 29/10
Repairing damaged casing pipe - by expanding patch with edges
coated with sealing material and granules, of hardness exceeding
that of patch and casing
C92-191751
Addnl. Data: YUREV V A, NEUDACHIN V P, NIKITIN V I

(54) СПОСОБ РЕМОНТА ОБСАДНОЙ КО-
ЛОННЫ

(54) METHOD FOR CASING REPAIR

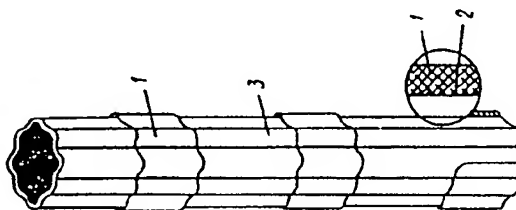
Sealing material (1) is put on edges of the longitudinally corrugated
pipe (3) and granules (2) of hardness exceeding that of the pipe (3)
and of casing pipe are put on the sealing material (1). Size of the
granules (2) is less than thickness of the pipe's (3). The pipe (3) is
lowered down the casing pipe into required position and pressed
against its inner surface.

The material may be in the form of sticky tape on which the
granules (2) are placed. During expansion of the patch (3) the
granules edges cut into the patch and the casing pipe and ensure a
strong contact on a shorter section. The sealing material (1) with the
granules (2) can be deposited practically in any width, but initially
the width of 200-400 mm is sufficient.

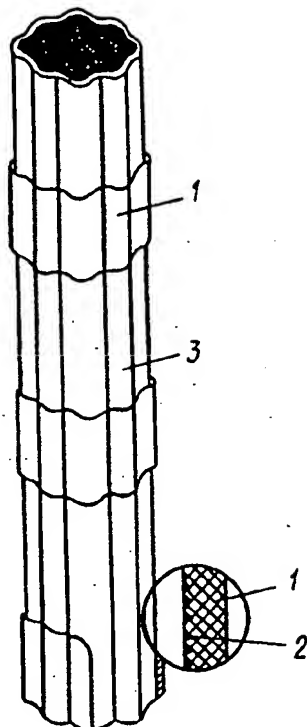
На чертеже изображена заготовка пластыря.

Герметизирующий материал 1 с применением твердого зернистого материала в виде крошки многогранной формы 2 наносят на металлическую гофрированную трубу 3.

The drawing depicts the patch blank.

The sealing material 1 employing hard granular material in the form of polyhedrally shaped small fragments 2 is applied to metallic corrugated tube 3.
